Bypass Filtration System, Hitachi 5500 Excavator : Thiess, Hunter Valley

FTA was approached to install a bypass filtration system on the hydraulics of a 5500 Hitachi Face Shovel being commissioned for Thiess at Liddell Coal in the Hunter Valley.

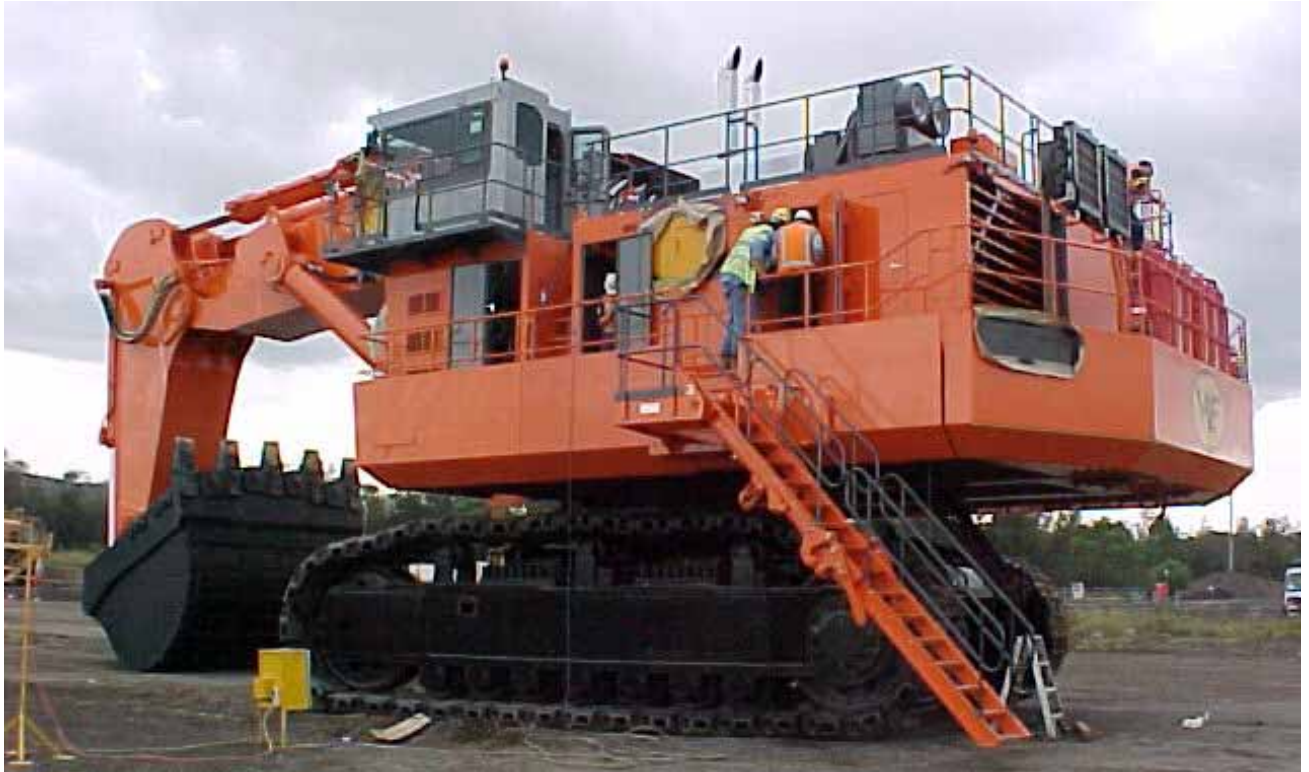
The shovel has a 6,500 litre hydraulic system so it was decided to install a JQ440 filtration system on board using a spare pump that was available in the hydraulic circuit.
